4 カ月ごとの水温変化_2020.8~ (Stn.2)

4 カ月ごとの塩分変化_2020.8~ (Stn.2)

4 カ月ごとの溶存酸素 (DO) 変化_2020.8~ (Stn.2)

4 カ月ごとのクロロフィル濃度変化_2020.8～ (Stn.2)

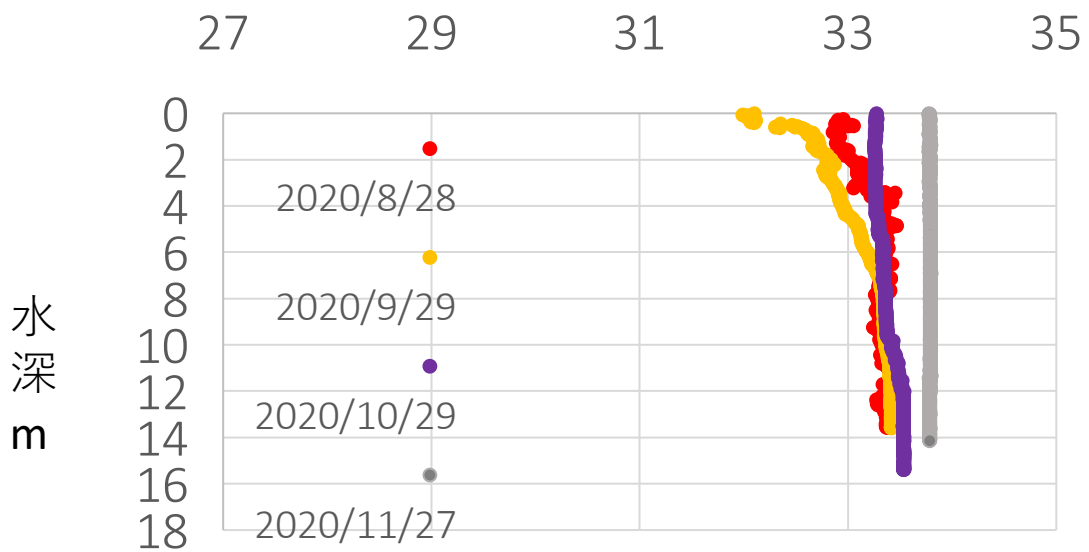
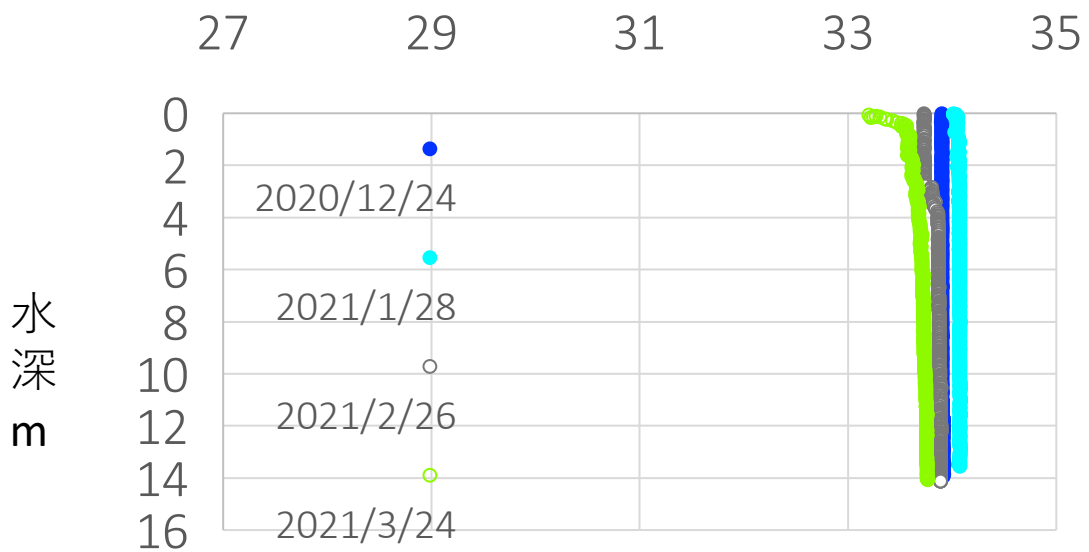
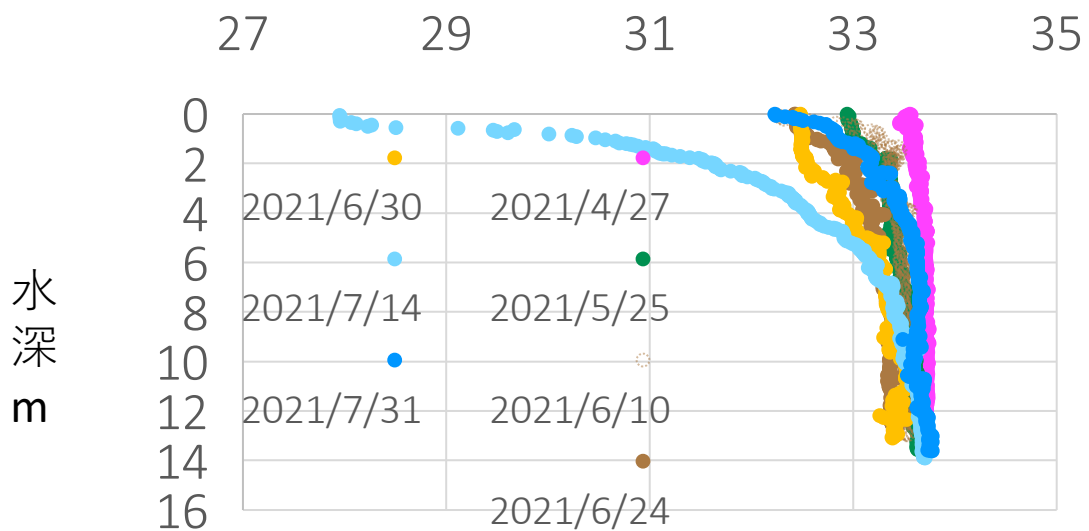
降雨後の表層水は塩分低下が見られる。

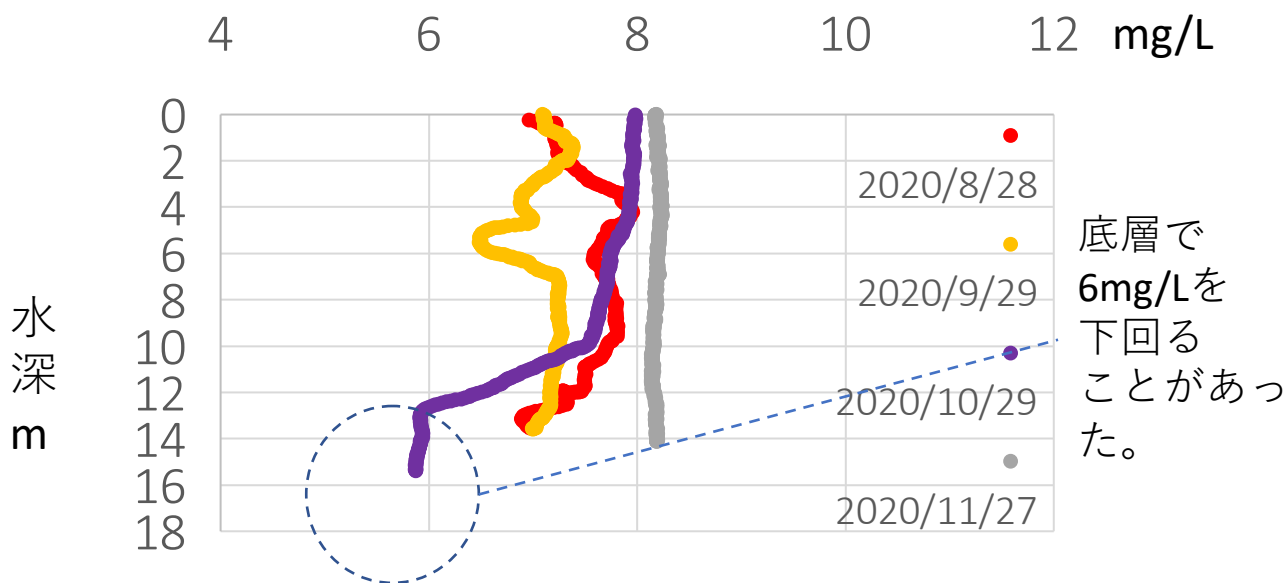
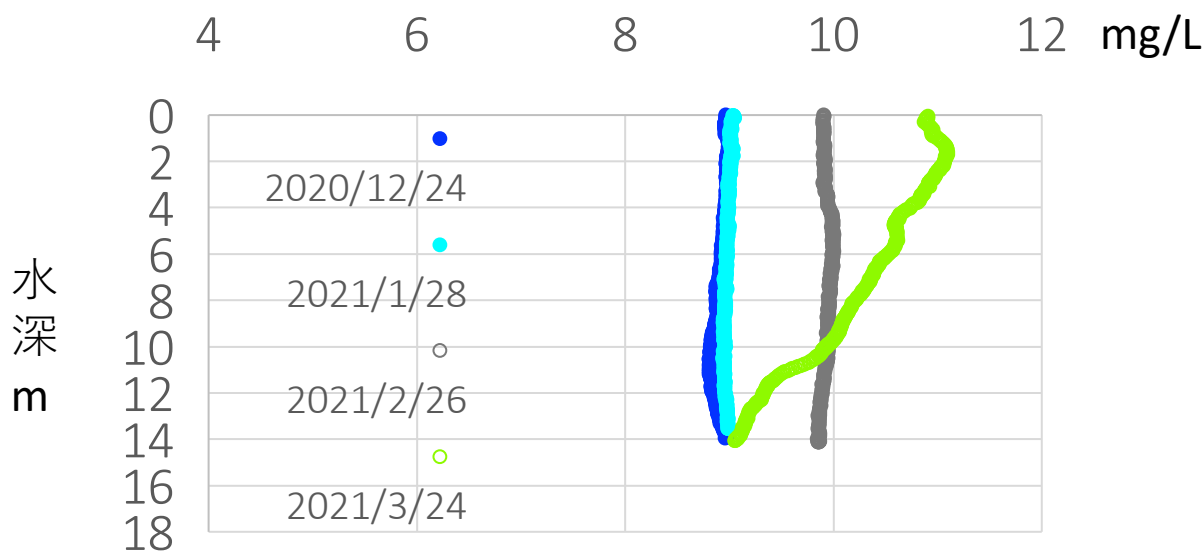
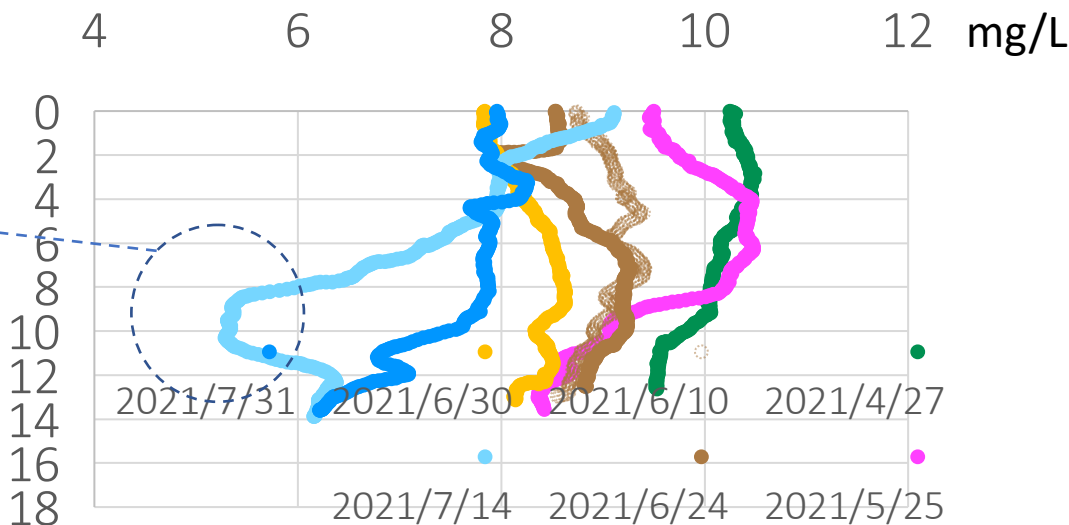
中層で 6mg/Lを 下回ることが あった。
