### 4 カ月ごとの水温変化\_2020.8~ (Stn.3)

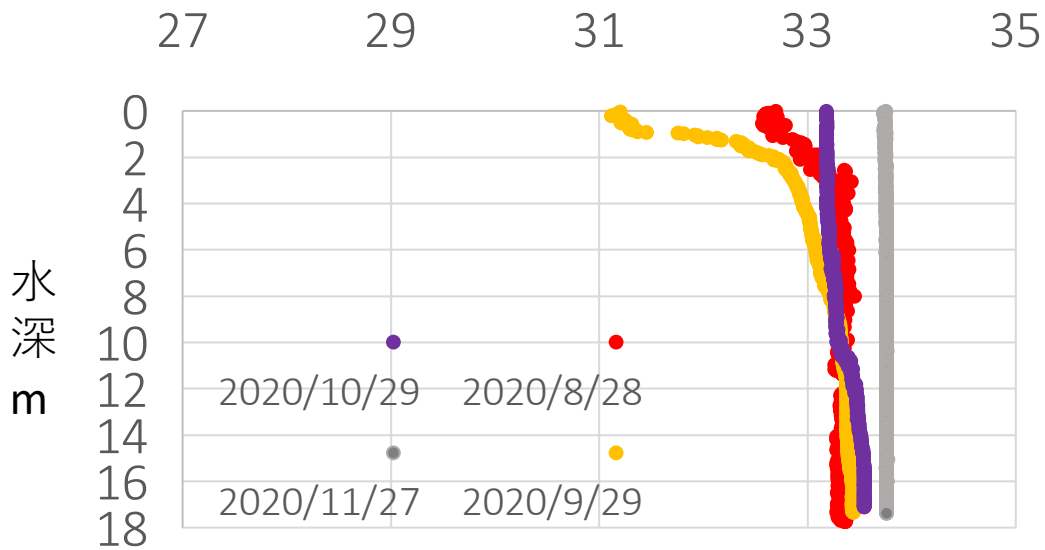
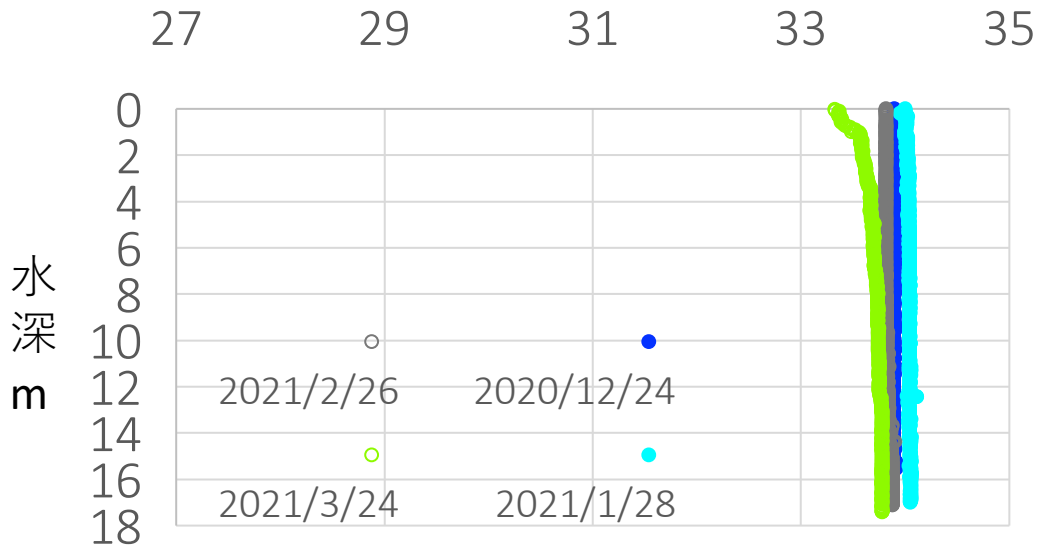
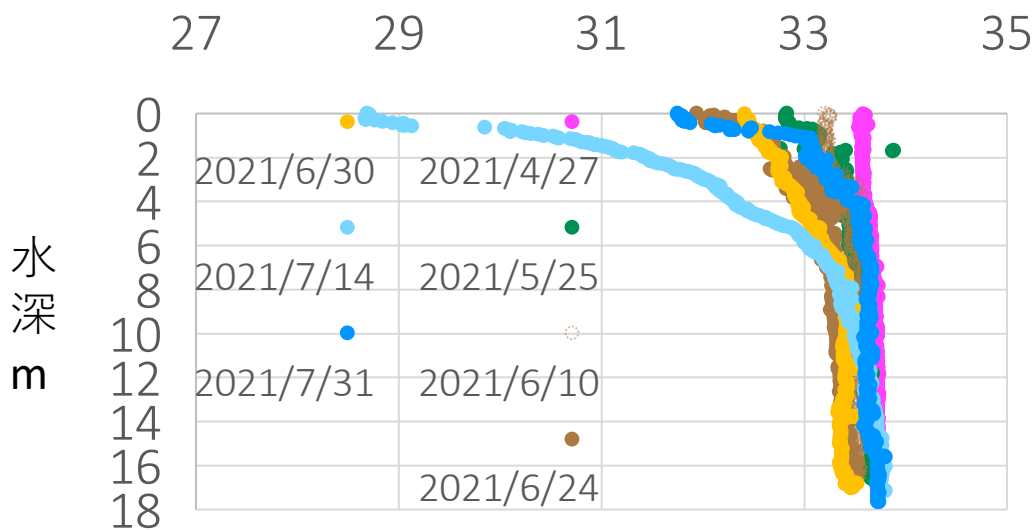
# 4 カ月ごとの塩分変化\_2020.8~ (Stn.3)

降雨後の表層水は塩分低下が見られる。

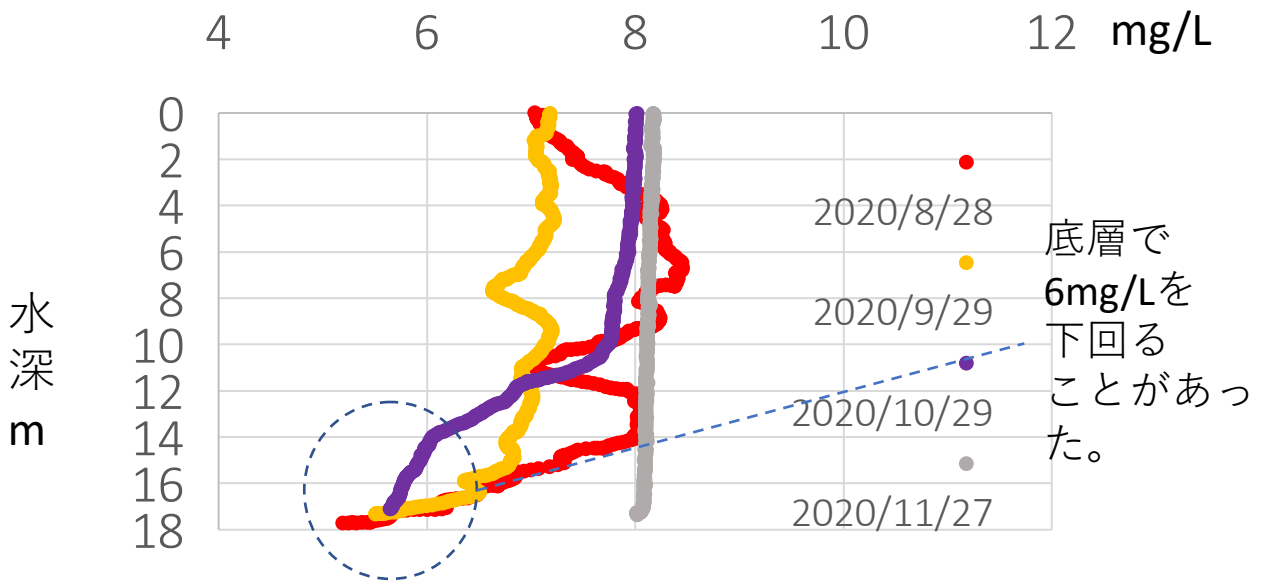
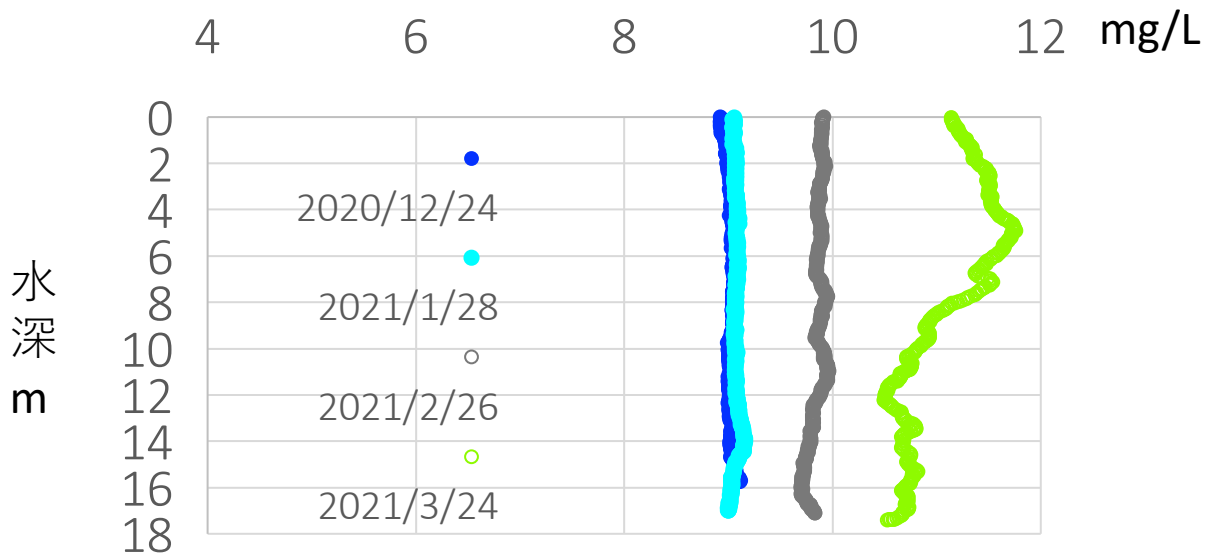
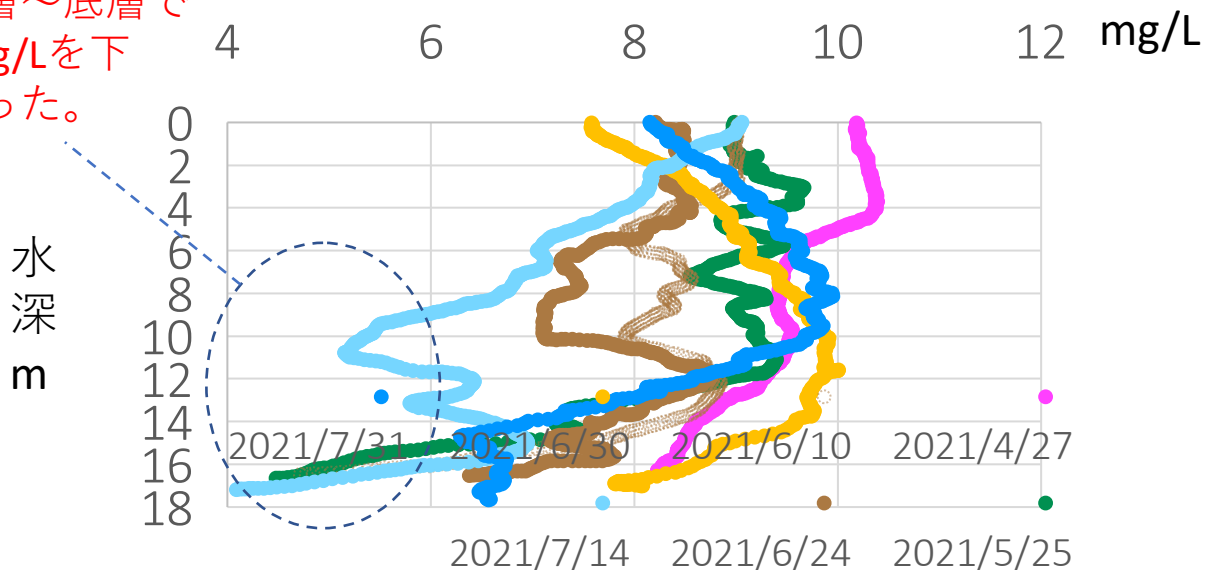
# 4 カ月ごとの溶存酸素 (DO) 変化\_2020.8~ (Stn.3)

中層～底層で 6mg/L を下 回った。
